## 12) 郷土玩具の安定化処理および修復

### 高田人形と的

## 12) Stabilization and Restoration of Folk Toys

### Takata dolls and archery targets

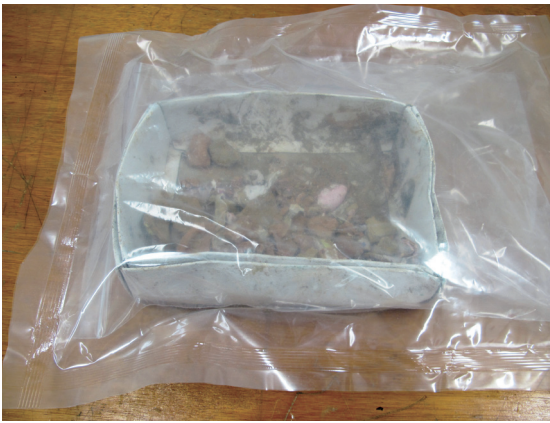
高田人形と的(まと)は、救出後、乾燥、くん蒸が施されたものの、通常環境では資料形状保持及び劣化防止が困難なため、新たな脱塩処理方法が確立されるまでの間、1年以上ガスバリア性袋に封入し保管されていました(図1)。

The recovered Takata dolls and archery targets were dried and fumigated after being salvaged. However, since it had been difficult to preserve their original forms and to prevent degradation in a normal environment, they were sealed in gas barrier bags and stored for more than a year until a new desalination method could be established (Fig. 1).

図1 ガスバリア性袋に封入した救出断片  
Fig. 1 Salvaged pieces sealed in a gas barrier bag

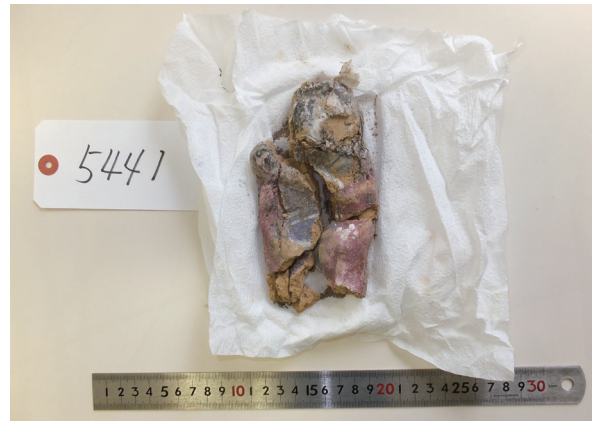
紙で梱包し収蔵していたため、薄葉紙が資料表面に固着し、彩色層損傷の原因になりました。構造上脆弱な首部での折損が多くみられ、泥の塊と化したもの、側面部で剥離し押しつぶされたものなど、ポリ袋入りの一個体を除き他はすべて破損していました(図2)。救出された断片を観察し、胴部の模様や断面の形状で一個体と判断できる資料から優先的に安定化処理と修復に取り掛かりました(図3)。その後、つぶれながらも比較的形状が明瞭に残っている資料を選別し処理をしていきました。

wrapped in tissue paper while in storage at the RTCM prior to the disaster, the tissue paper affixed to the surface of the salvaged dolls and caused damage to the coloration layer. The neck parts were broken in many items due to their fragile nature. Some dolls turned into a lump of dirt, while others were crushed after coming apart on the sides. Except for one salvaged item which was stored in a plastic bag, all other items were damaged (Fig. 2). After observing the salvaged doll parts, stabilization and restoration was initially performed on the sets of pieces that could be identified as one single doll based on the patterns on the body parts and the cross-sectional shapes (Fig. 3). Subsequently, treatment was performed on the selected salvaged objects which retained their shapes relatively well despite having been crushed.

図2 救出された断片  
Fig. 2 Salvaged piece

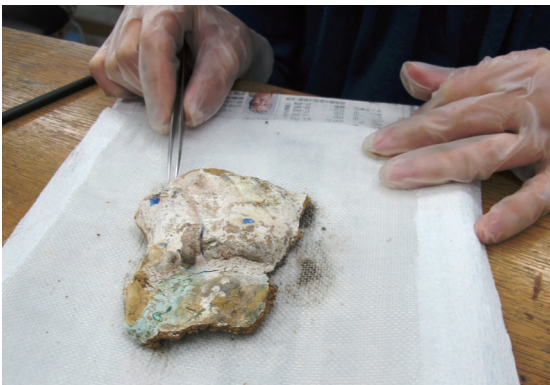
図3 付着した薄葉紙を除去しながらクリーニング  
Fig. 3 Cleaning a fragment while removing the attached tissue paper

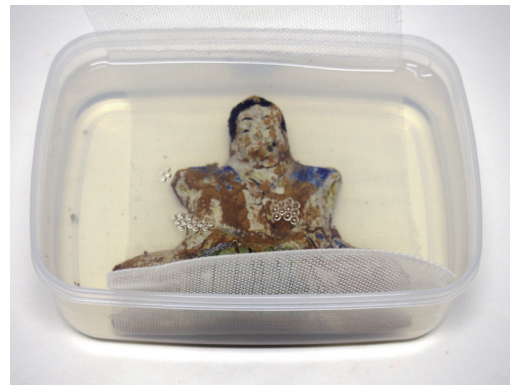
図4 アクリル樹脂に浸漬し材質強化  
Fig. 4 Strengthening the materials by soaking them in an acrylic resin solution

土製で未焼成の高田人形は、現状のまま水に浸漬し脱塩処理を行うのは不可能でした。このため、3~5%に調整したアクリル系合成樹脂水溶液に浸漬し、素材強化を行いながら塩分除去を実施しました(図4)。低濃度水溶液から順次高濃度水溶液へ短時間の浸漬と乾燥を繰り返して、素材強化の状況を目視観察しました。浸漬実施回数は資料の状況に応じ異なりますが、概ね3~5回です。

It was impossible to desalinate the earthen and unbaked Takata dolls by soaking them in water. For this reason, desalination was performed while reinforcing their materials by soaking the dolls in a 3% to 5% acrylic synthetic resin solution (Fig. 4). The dolls were first soaked in a lower concentration solution and then soaked in solutions with increasingly higher concentrations. Each time, the dolls were soaked for a short period, dried, and then the strength level of its materials was visually checked. While the amount of soaking depended on the conditions of the salvaged objects, most of the dolls had to be soaked three to five times.

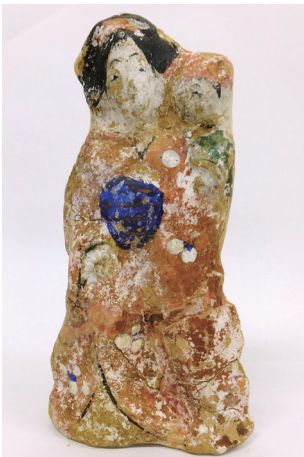
図5 修復・復元後の高田人形  
Fig. 5 Restored and partially reproduced Takata doll

脱塩・強化処理が終了した断片はエポキシ樹脂で接合・復元し、周囲の色と違和感がないように、アクリル絵の具で古色仕上げしました(図5)。つぶれた状態の資料は、再度低濃度のアクリル系合成樹脂水溶液に浸漬後、半乾燥し相当量水分が残った状態で、粘土で作製した保持型に当てながら形状を徐々に補正しました。欠失箇所は、保存してある断片から該当するものを探して接着・復元しました。断片が見つからない欠失箇所は、ガラス繊維を板状にエポキシ樹脂で加工し、欠失箇所の形状に合わせて接着、エポキシパテで充填し形状復元しました(図6)。

The desalinated and strengthened pieces were joined together using an epoxy resin, and were given an antique finish using acrylics to make them blend in with the colors of the surrounding pieces (Fig. 5). Crushed objects were soaked in a low-concentration acrylic solution once again, partially dried, and then their forms were gradually restored while a considerable amount of moisture was still retained in them by pressing the dolls against a holding mold made from clay. Relevant pieces were chosen from the preserved pieces

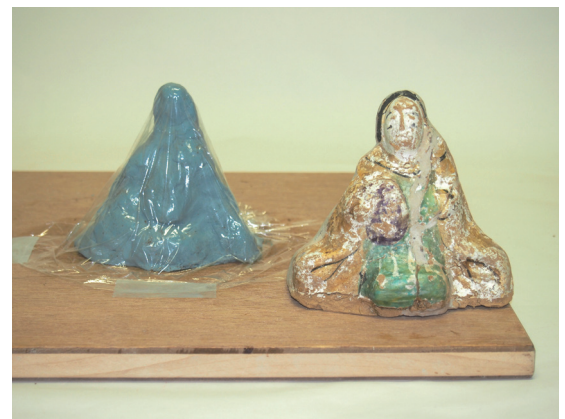
図6 復元途中の高田人形と粘土で作製した保持型  
Fig. 6 Takata doll being restored and a preservation mold made from clay

and attached to areas that had lost pieces. When there was no relevant piece, the area which the missing piece had occupied was shaped and restored in the following manner: glass fibers were processed into sheets using epoxy resin, then those sheets were attached to the area of loss according to its shape, and finally the area was filled with an epoxy paste (Fig. 6).

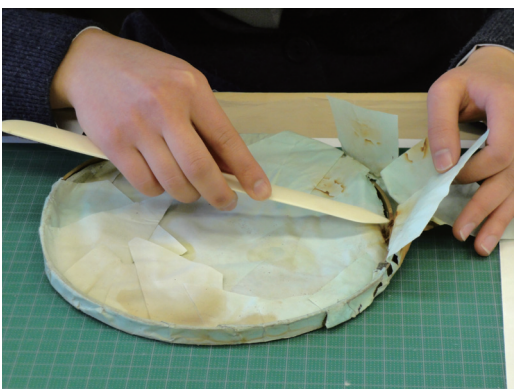
図7 竹枠から本紙を外す  
Fig. 7 Removing the front sheet from the bamboo frame

処理した資料は海水損し、細かな砂が本紙と竹枠の隙間に入り込み、竹枠の針金の錆化、本紙の歪み・剥離・損傷、手描き文様の退色などの劣化が著しく進行していました。

The objects treated in this project had been damaged by seawater. Fine sand had entered into the gap between the front sheet and the bamboo frame. A considerable amount of

degradation had progressed including corrosion products on the bamboo frame wires, front sheet deformation and discoloration of the hand-drawn designs.

脱塩処理は的を解体（図7）して本紙、裏紙および竹枠に分けて（図8）行い、処理液が水道水の塩化物イオン濃度と同程度の値になった時点で終了としました。本紙は顔料の流出を避けるため、刷毛などを用いたドライクリーニング（図9）で砂や泥を充分除去した後、湿りを加えた吸い取り紙に挟み、脱塩処理を行いました（図10）。本紙の脱塩処理効果は間に挟んだ吸い取り紙の塩分量で評価し、上記の挟み込みによる処理を2回繰り返して終了としました。裏紙は本紙と同様にドライクリーニングした後、ポリエチレンネットの間に挟み、養生しながら流水と精製水による洗浄・脱塩を2回行いました。竹枠は12%次亜塩素酸ナトリウム水溶液10ccを2Lの水道水で希釈した液に30分浸し、その後、半日おき毎に水換えしながら4日間精製水に浸漬しました。

The targets were disassembled (Fig. 7), and desalination was performed separately on the front sheet, the back lining paper, and the bamboo frame (Fig. 8). Desalination was considered complete when the chloride ion concentration level of the treatment solution reached a level close to that of tap water. To prevent the pigment from running, the front sheet was dried and then cleaned using a large brush to completely remove the sand and dirt (Fig. 9). Then, desalination was performed by sandwiching the front sheet with moisturized blotting paper (Fig. 10). The desalination results of the front sheet was assessed by the salinity of the blotting paper sheets used in the process. Desalination of the front sheet was complete after repeating the above described treatment twice. The back lining paper was similarly treated by dry cleaning. Then, after surrounding it with polyethylene nets, the lining paper was washed, desalinated, and cured, using running water and then purified water. This washing process was repeated twice. The

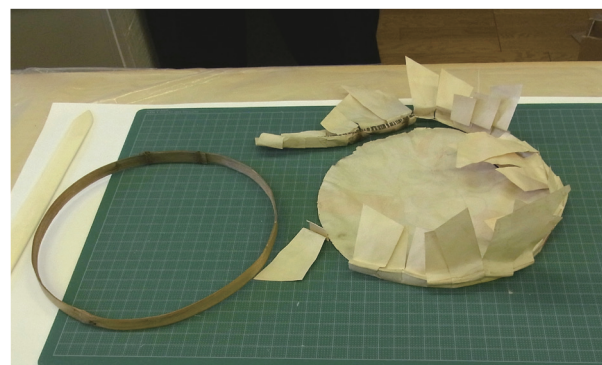
図8 解体した本紙と竹枠  
Fig. 8 Disassembled front sheet and bamboo frame

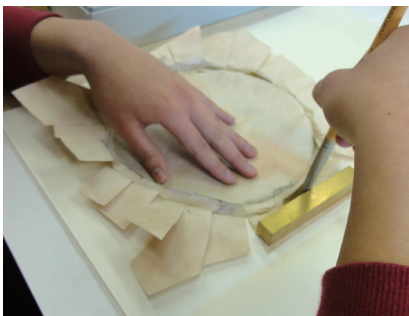
図9 本紙のドライクリーニング  
Fig. 9 Dry cleaning the front sheet

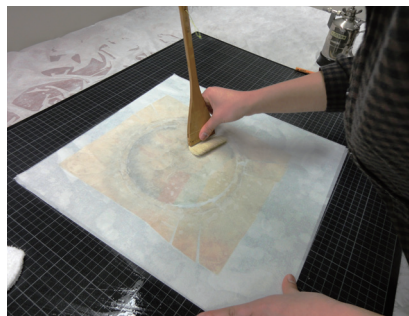
図10 本紙の脱塩処理  
Fig. 10 Desalinating the front sheet

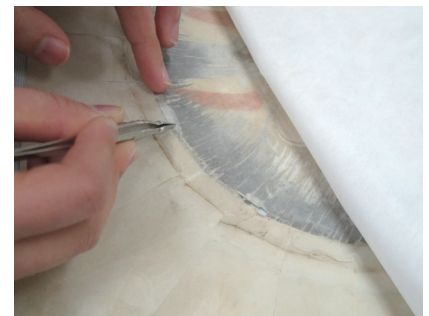
図11 本紙損傷箇所を楮紙で補強  
Fig. 11 Reinforcing a damaged area on the front sheet using *kozo* paper

脱塩処理が終了した本紙は、損傷個所を楮紙で補強（図11）した後、裏面全体を1%のMCを用い楮紙で裏打ち強化しました（図12）。欠失個所のある資料は、市販の洋紙を欠失個所の形状に合わせて充填し、損傷個所の補強と同様の手順で楮紙を用い本紙と接着しました。裏打ちした楮紙は本紙の大きさに切り揃え、本紙にならって切り込みを入れ、錆びた針金をステンレスの針金に置き換え、整形した竹枠に2%のMCで貼り込みました（図13）。なお、修復したことにより本紙の図柄の大きさが0.1～1mm変化したため、図柄に合わせて竹枠の大きさを調整しました。その後、裏紙を2%のMCで接着・乾燥後、補強し

The damaged areas of the desalinated front sheet were reinforced with *kozo* (mulberry) paper (Fig. 11). Then, the entire back side was reinforced by lining it with *kozo* paper using 1% methylcellulose (Fig. 12). Targets with missing material were treated by filling the area with commercial paper cut into shapes to fill the gaps, which were glued to the front sheet using *kozo* paper and employing the same procedure used for reinforcing the damaged areas. The lined *kozo* paper was trimmed to the size of the front sheet, and then small cuts were made on the fringes in a similar manner to the cuts made at the fringe of the front sheet. The rusted wires were

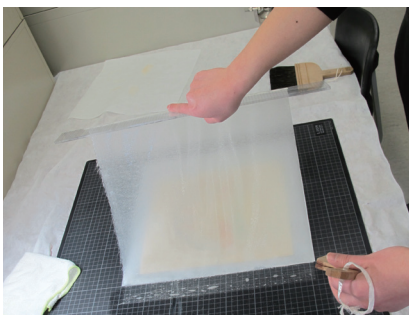
図12 楮紙による本紙の裏打ち強化  
Fig. 12 Strengthening the front sheet by lining with *kozo* paper

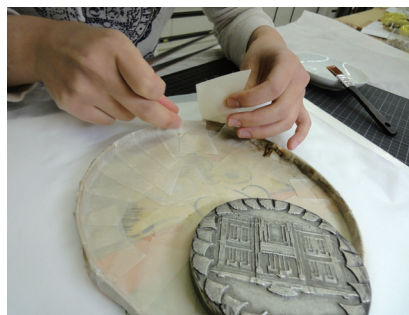
図13 竹枠に本紙を貼り込む  
Fig. 13 Pressing in and gluing the front sheet onto the bamboo frame

replaced with stainless steel wires. Then the back lining paper was pressed in and glued onto the shape-adjusted bamboo frame using 2% methylcellulose (Fig. 13). Since the restoration work had caused the size of the front sheet design to change by 0.1 to 1 mm, the size of the bamboo frame was adjusted to the design. Finally, after gluing the lining paper with 2% methylcellulose and drying it, the reinforced areas and areas of loss supplemented with non-Japanese paper were colored using Japanese paint (Fig. 14) to conclude the restoration process (Figures 15 and 16).

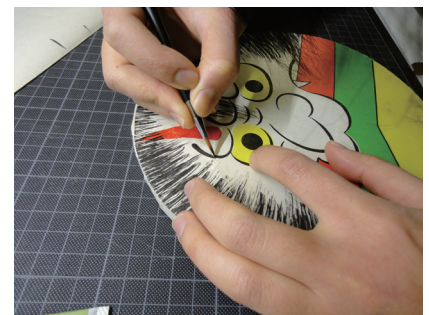
図14 補修箇所の補彩  
Fig. 14 Supplementary coloring of repaired parts

た個所や洋紙で補った欠失個所を日本画絵の具で補彩し (図14)、仕上げとしました (図15・16)。

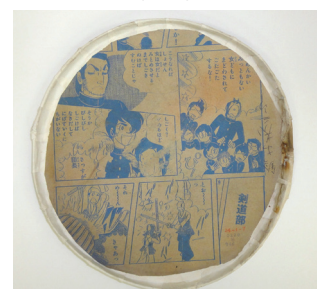
図16-1・16-2 修復後の表面・裏面  
Fig. 16-1 & 16-2 Post-restoration target front and back view
