16) 岩手県指定文化財吉田家住宅の再生をめざして －救出された部材の被災状況調査－

岩手県指定文化財吉田家住宅の救出

16) For the Restoration of the Yoshida Family Residence, a Designated Cultural Property of Iwate Prefecture -Survey of a Damage to Salvaged Building Material-

救出された吉田家住宅建築部材の脱塩実験

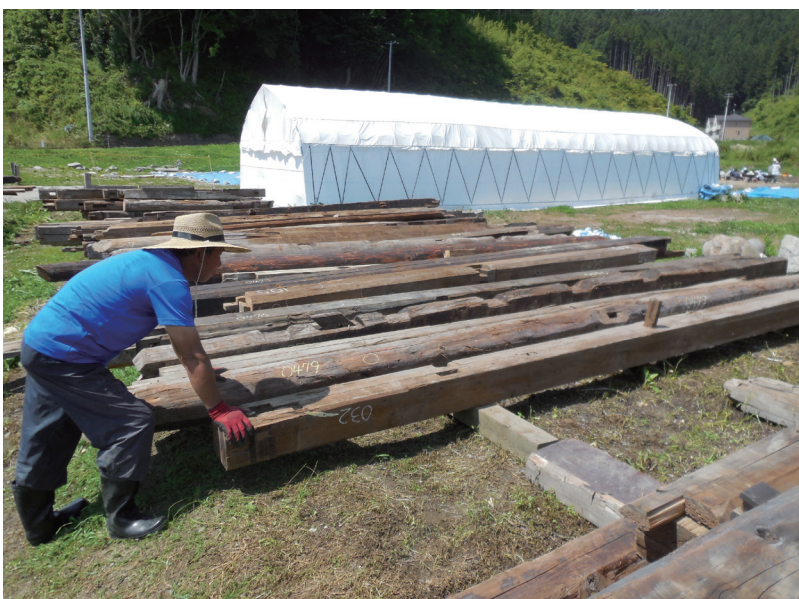
当住宅は建築後400年の間、11回に及ぶ津波や、洪水、大火を経験し、その都度それらを乗り越えてきましたが、平成23（2011）年3月11日に発生した東北地方太平洋沖地震による大津波によって主屋と各種付属屋が全て流失する等、壊滅的被害を受けました。座敷廻り部分は屋敷の裏側に、茅葺屋根は南西側に位置する諏訪神社を回った気仙小学校側に300mほど流されてしまいました。しかし、岩手県立博物館、八戸工業大学・月館敏栄教授とその学生、所有者らによる懸命な部材の救出活動が行われ、同年6月中旬には主要構造部材の7割程度に相当する1016本の部材を救出することができました（図2）。陸前高田市の復興計画の中にも、生涯学習拠点の設置としての吉

by the Iwate Prefectural Museum, Professor Toshiei Tsukidate and his students at the Hachinohe Institute of Technology, and the owner of the residence. By mid-June of that year, 1,016 building components which make up about 70 percent of the primary structural components were salvaged (Fig.2). The restoration of the Yoshida Family Residence as a center for lifelong education is declared in the restoration project of Rikuzentakata City. Restoration of the residence using salvaged structural material will soon begin.

図2 回収した部材

Fig. 2 Collected building material

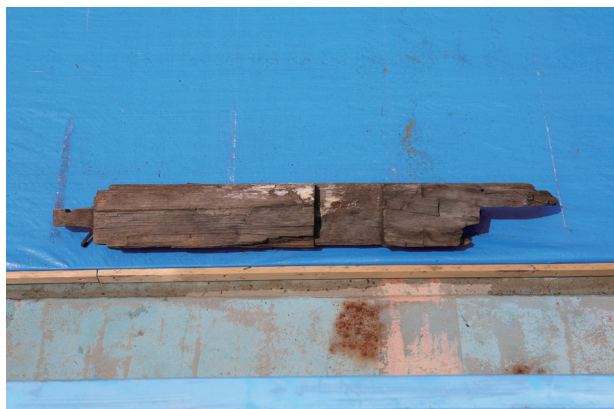
調査用部材を肉眼観察し、表面に相当量の土砂や泥が固着し、多量の塩分を含有すると推定される資料（図3a、表1で保悪部材と記載）、表面に土砂や泥の固着は確認されず健全と判断される部材（図3b、表1で保良部材と記載）の2種類についてそれぞれ3本ずつ選別しました。

The building material to be researched was observed. The material was screened for two things. First, items onto which a substantial amount of dirt, sand, and mud was affixed and which were presumed to contain a large amount of salts (Fig.3a,

referred to as building material in poor condition in Table 1). In addition, material which was judged to be sound with no dirt, sand, and mud affixed onto its surface (Fig.3b, referred to as well preserved building material in Table 1).

図3a 保悪部材
 Fig. 3a Building material in poor condition

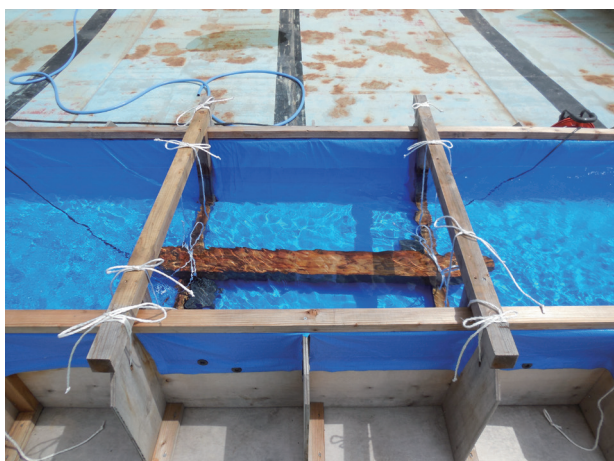
図4 部材脱塩実験
 Fig. 4 Desalination process on building material

- ①部材表面を高圧洗浄機（精和産業株式会社）で丁寧に洗浄し、表面に固着する土砂や泥を可能な限り除去する
- ②水槽に約1,500ℓの水道水を入れ、部材を水槽底面にロープで固定し、完全に浸漬する（図4）
- ③水槽内の水を攪拌し、部材から溶出した塩化物イオンが水槽内に均一になるよう、水槽の2箇所にポンプを設置する（図5）
- ④部材浸漬後、24時間ごとに部材を引き上げ、部材から滴る水を採水する。また、水槽の中心と右上端および左下端に採水ポイントを設け、各々表層、中層、底層の計3か所から約100mlの脱塩液を採取する。

- (1) Wash the surface of the material carefully using a high-pressure washer (manufactured by Seiwa Spray Pump Inc.) to remove as much, dirt, sand, and mud on the surfaces as possible.
- (2) Put 1,500 L tap water in a tank and attach the building material to the bottom of the tank to immerse it completely (Fig.4).
- (3) Stir water in the tank and set pumps at two points in

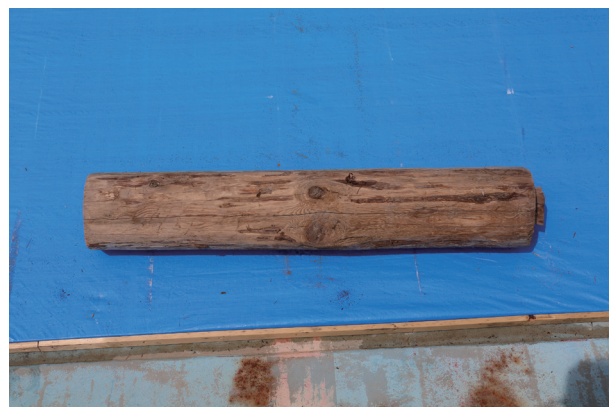
図3b 保良部材
 Fig. 3b Building material in good condition
