11) 民俗芸能用装身具の安定化処理および修復 ア. 簪 高田歌舞伎に使用された装身具

11) Stabilization and Restoration of Folk Performing Art Accessories - Ornamental Hairpins -

簪類の安定化処理および修復

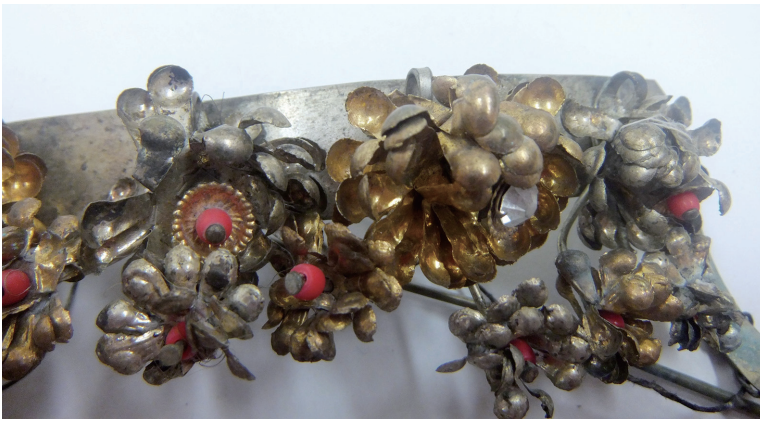
簪は救出後、ドライクリーニングが施されました。その後ガスバリア性袋に保存されてきましたが、錆化が進行していました。形全体の歪み・折損・剥離などは随所にみられ、表面や入り組んだ個所に泥や細砂が固着し、金属は劣化により全体がくすみ、水色や緑青色の錆も散見されました(図1・10)。特に、飾りの基部となっている鉄製の板状部位は損傷著しく、被災前に補修した痕跡も認められました。また、ビラビラ簪の銀色の垂れ飾りは、震災前に相当腐食が進み樹脂を塗りこんで応急処置をしていたと推測される個所も多々あり、欠損や錆化は津波被害に拠るものだけではないと推定されました(図2)。

図1 お姫様簪の花飾り損傷状況
Fig. 1 Damaged flower ornaments of a princess kanzashi

of the entire shape, breakage, detachment and further damage was observed in almost all areas of the items. Furthermore, dirt and fine sand grains had attached to the surface and areas of elaborate ornamentation, the metal parts appeared dull due to degradation, and light blue colored corrosion products and green colored corrosion products were observed sporadically (Figures 1 and 10). The flat iron parts, the foundation of the ornamentations, were badly damaged, and traces of pre-disaster repair was also observed. In addition, since it was observed that the silver dangling ornaments of the *birabira kanzashi* presumably had been given emergency treatment prior to the disaster by applying resin in the areas of severe corrosion damage, it was assumed that this disaster was not the only cause of structural deformation and rust (Fig. 2).

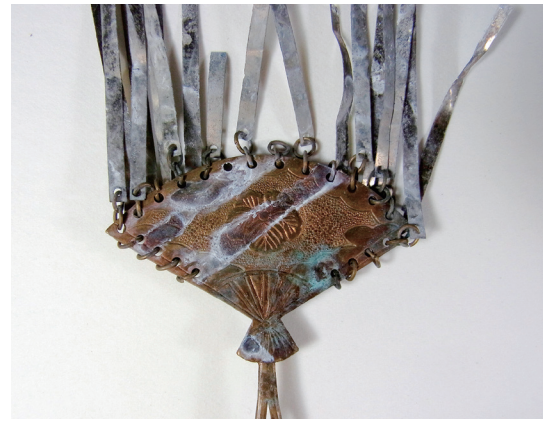
図2 錆化したピラピラ簪
Fig. 2 Rusted birabira kanzashi

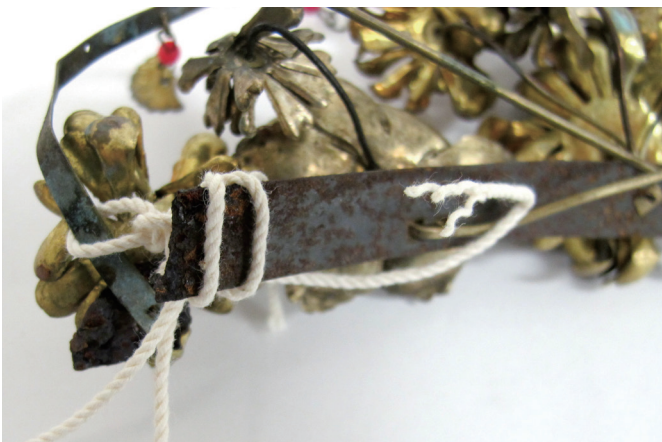
図3 処理前の補強
Fig. 3 Pre-treatment reinforcement

で、ごく一部にのみ錆が認められる資料はキレート剤に浸漬せず、高吸水性樹脂にキレート剤を浸み込ませ、錆だけに反応するようにしました。なお、キレート剤の使用に当たっては予め真鍮板および採取した錆片で予備実験し、資料表面の色調に影響を与えない薬剤と浸漬時間を選択しました。薬剤処理後は資料を精製水で充分洗浄し、洗浄液のpHおよびCl⁻濃度が水道水とほぼ同じ値になるまで洗浄を続けました。また、クリーニング・脱塩処理工程中のさらなる損壊を防ぐため、損傷箇所は和紙やたこ糸で養生し(図3)、補強してから処理に取り掛かりました。

Extra caution was taken during the stabilization to conserve the non-damaged metal surface areas from being damaged by chemical agents. Some flat ornament *birabira kanzashi* items in which corrosion was observed only on a small portion were treated with high water absorption resin in which a chelate agent was added so that the agent reacted only with the fully-corroded whole item in a chelate solution. As for the use of a chelate agent, preliminary experiments were conducted using a brass plate and collected corrosion product samples. Based on the results of those experiments, chemical agents and soaking durations which did not affect the surface color of the salvaged objects were selected. The items were thoroughly washed in purified water after being treated by chemical agents, and the washing continued until the pH and the Cl concentration levels were reduced to values close to those of tap water. Furthermore, damaged areas were repaired by applying Japanese paper and kite strings (Fig. 3) prior to performing treatment to reinforce them in order to prevent any further damage from occurring

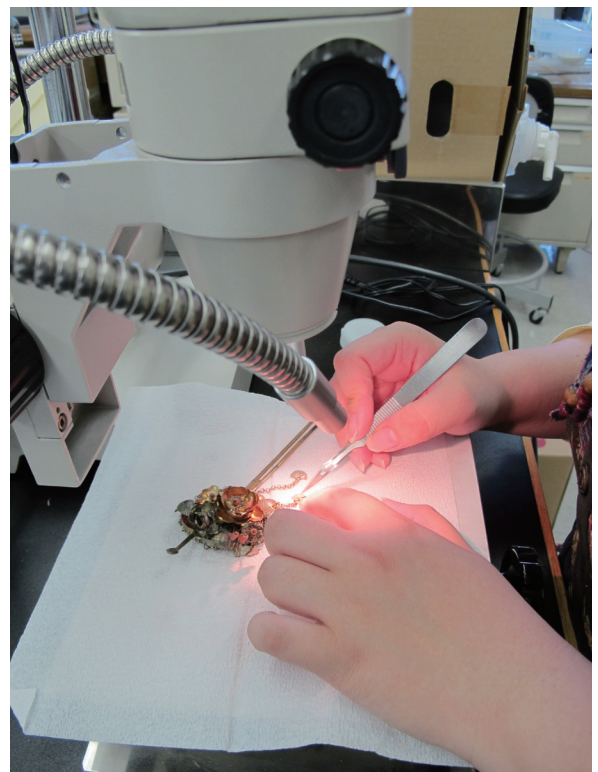
図4 双眼実体顕微鏡下でのクリーニング
Fig. 4 Cleaning using a binocular stereo microscope

これらの調査結果から、錆はできるだけ除去することとし、双眼実体顕微鏡下で筆やメスによる物理的処理を優先的に行い(図4)、キレート剤を用いた化学的処理は、堅い錆を軟化する程度に留めました(図5)。メスや筆で除去しきれない堅い錆が固着している場合には、資料の状況に応じてキレート剤に短時間浸漬し錆を軟化させ、処理直後に超音波洗浄器を用い精製水で薬剤を除去し、その後、残存している錆を検鏡下で再度除去する工程を繰り返し行いました。ビラビラ簪やお姫様簪は、金属の花飾りが幾重にも重なりあい入り組んでいるため、このクリーニング処理の工程を少なくとも3回繰り返し行いました。なお、油分の付着が認められる資料は、有機溶剤で除去しました(図6)。

surgical knives and utilizing a binocular stereo microscope (Fig. 4), while chemical treatments using a chelate reagent were only used for softening rigidly-affixed corrosion (Fig. 5). Areas with fixed substances which could not be completely removed by brushes or surgical knives were, depending on the conditions of the salvaged objects, soaked for a short period of time in a chelate solution to soften attached corrosion. Immediately after this treatment, the items were washed in purified water using an ultrasonic cleaner to remove the agent and subsequently, the remaining corrosion products were removed while observing them through a microscope. This process was then repeated. Since the *birabira kanzashi* and princess *kanzashi* had complicated ornamentations containing multiple layers of metal flower ornaments, this cleaning process had to be repeated at least three times. Oil adhering to salvaged objects was removed with an organic solvent (Fig. 6).

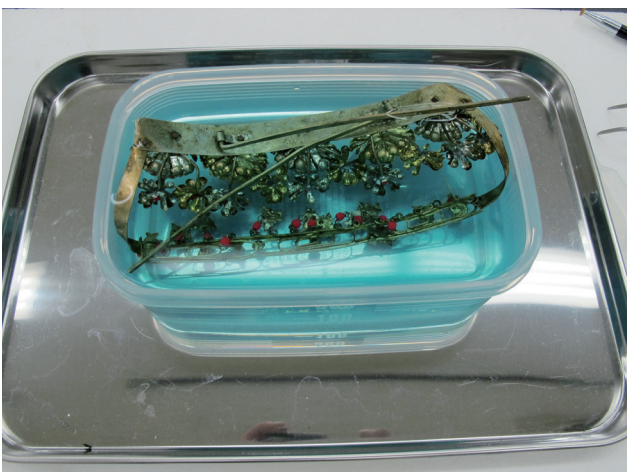
図5 錆を軟化するためキレート剤に浸漬
Fig. 5 Soaking in a chelator solution to soften the rust

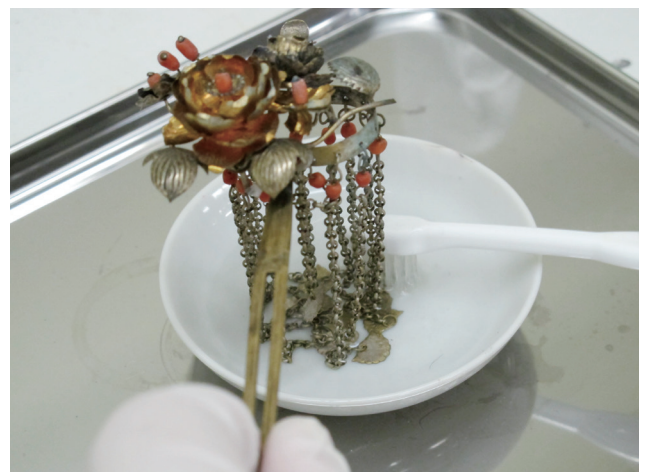
図6 有機溶剤で油分を洗浄
Fig. 6 Rinsing off oil using an organic solvent

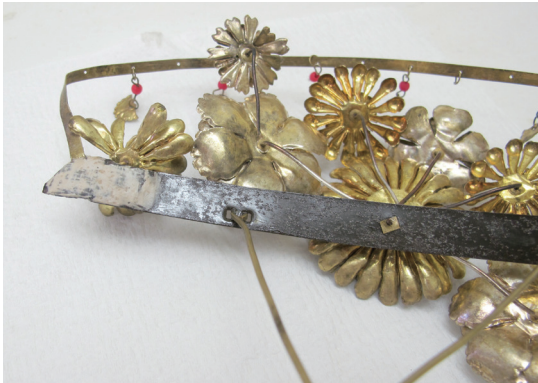
図7 樹脂による折損・剥離個所の補強
Fig. 7 Reinforcement of broken and detached parts using resin

安定化処理を終了後、綿棒を用い双眼実体顕微鏡下で再度表面をクリーニングしました。垂れ飾りなど非常に脆弱な薄片状の金属は和紙で、お姫様簪の鉄製部分の比較的厚い部位はガラス繊維で裏打ちし、エポキシ樹脂で強化しました(図7)。折損箇所はエポキシ樹脂で接着し(図8)、欠損箇所はエポキシパテで復元し、アクリル絵の具で古色仕上げを行いました。歪みの激しかったお姫様簪、ビラビラ簪は、最後にバランスをみながらピンセットなどで全体の形を整えていきました(図9・11・12)。

Subsequent to performing stabilization, the surface of the treated hairpins was cleaned again with cotton swabs using a binocular stereo microscope. The extremely fragile ultra-thin metal parts such as the dangling ornaments were lined with Japanese paper while comparatively thick parts such as the iron parts of the princess *kanzashi* were lined with glass fiber, and then strengthened with epoxy resin (Fig. 7). Broken parts were re-attached using epoxy resin (Fig. 8), and areas with missing material were reproduced using a paste epoxy and giving them a finish containing acrylics. The severely deformed princess *kanzashi* and *birabira kanzashi* items were, as a final treatment,

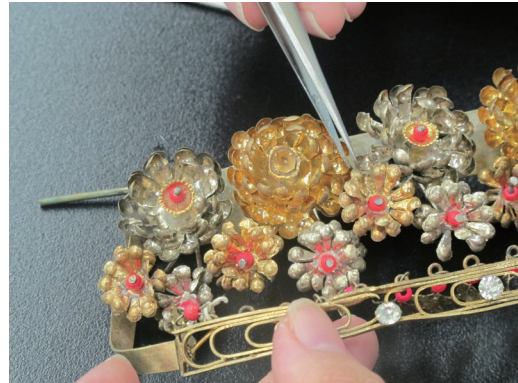
図8 花卉の接着
Fig. 8 Attaching a petal

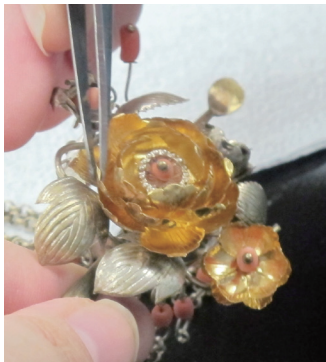
図9 全体の形を整える
Fig. 9 Restoring the overall shape

molded into their original shapes using tweezers while maintaining the overall symmetry of the object (Figures 9, 11 and 12).

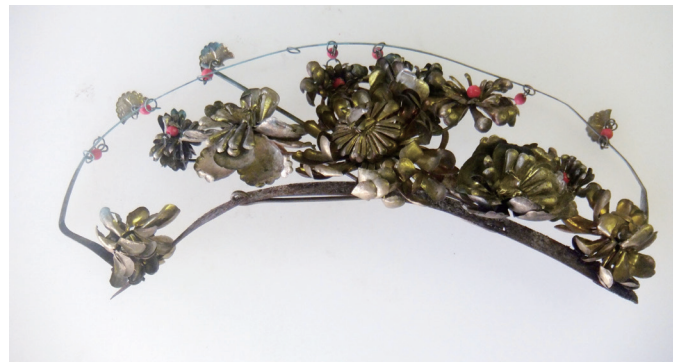
図10 修復前お姫様簪
Fig. 10 Princess *kanzashi* prior to treatment

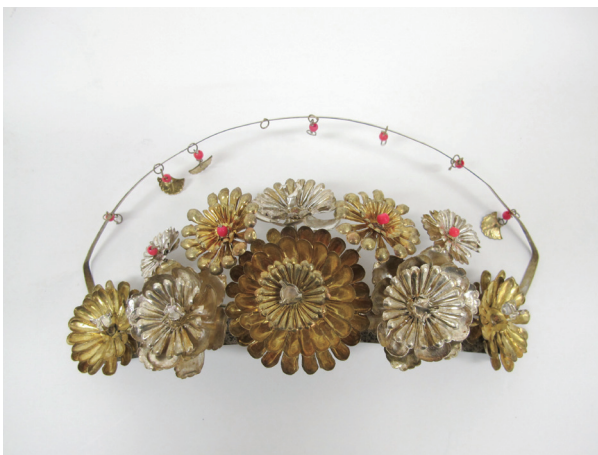
図11 修復後お姫様簪
Fig. 11 Princess *kanzashi* after treatment

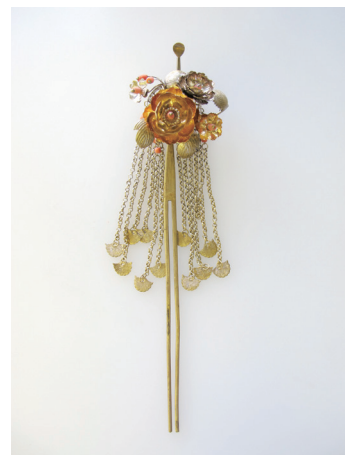
図12 修復後ピラピラ簪
Fig. 12 *Birabira kanzashi* after treatment
