16) 岩手県指定文化財吉田家住宅の再生をめざして －救出された部材の被災状況調査－

岩手県指定文化財吉田家住宅の救出

16) For the Restoration of the Yoshida Family Residence, a Designated Cultural Property of Iwate Prefecture -Survey of a Damage to Salvaged Building Material-

救出された吉田家住宅建築部材の脱塩実験

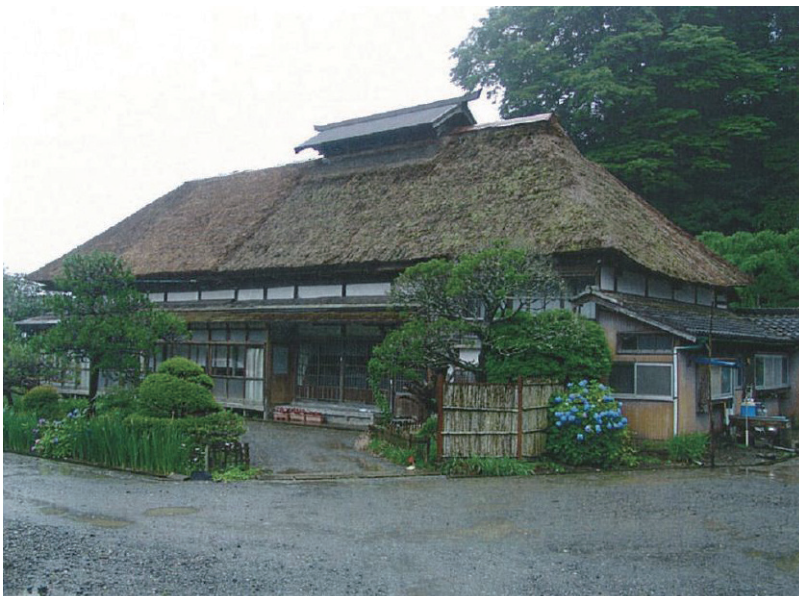
図1 震災以前の吉田家住宅（母屋）
東北工業大学 高橋恒夫氏提供

Fig. 1 The Yoshida Family Residence (main building) before the earthquake
Provided by Prof. Tsuneo Takahashi of the Tohoku Institute of Technology

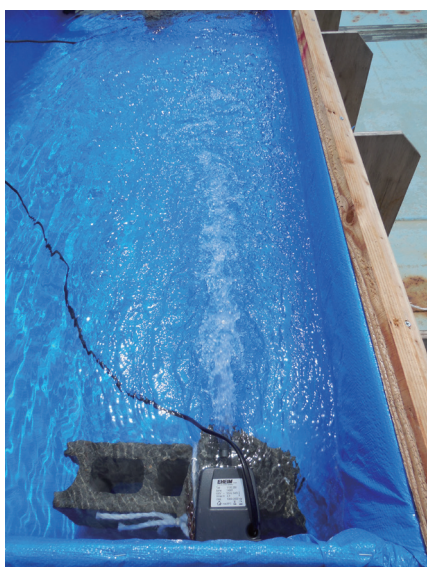
図5 水槽内に設置した水中ポンプ
 Fig. 5 A submersible pump placed in the tank

- ①部材表面を高圧洗浄機（精和産業株式会社）で丁寧に洗浄し、表面に固着する土砂や泥を可能な限り除去する
- ②水槽に約1,500ℓの水道水を入れ、部材を水槽底面にロープで固定し、完全に浸漬する（図4）
- ③水槽内の水を攪拌し、部材から溶出した塩化物イオンが水槽内に均一になるよう、水槽の2箇所にポンプを設置する（図5）
- ④部材浸漬後、24時間ごとに部材を引き上げ、部材から滴る水を採水する。また、水槽の中心と右上端および左下端に採水ポイントを設け、各々表層、中層、底層の計3か所から約100mlの脱塩液を採取する。

the tank so that the amount of chloride ions flowing out from the building material will be even (Fig.5).

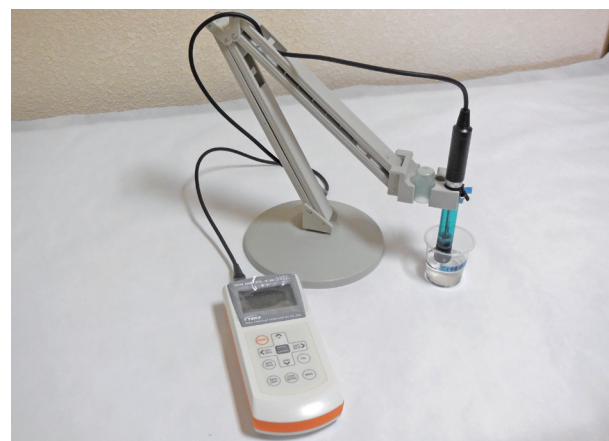
図6 塩化物イオン濃度計測に用いた機材
 Fig. 6 A device used to measure chloride ion concentration

ハンディ塩素イオンメータ（TiN-5102i型、東興化学研究所製）を用い、採水した脱塩液に含まれる塩化物イオン濃度の測定を実施する（図6）。

E. Use a Handy Chloride Ion Meter (TiN-5102i type, manufactured by Toko Kagaku Kenkyusho) to measure the chloride ion concentration contained in the desalinated water (Fig.6).
